BELZONA REPAIRS HIGH VOLTAGE BREAKER

ID: 5233

Industry: Power

SF6 High Voltage Breaker.

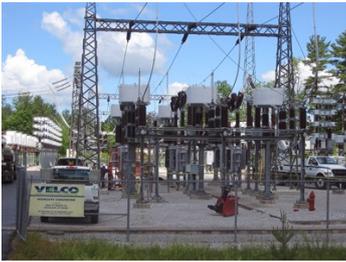
- * Overview of the converter station ,
- * The leaking area ,
- * Completed surface preparation ,
- * Completed application ,

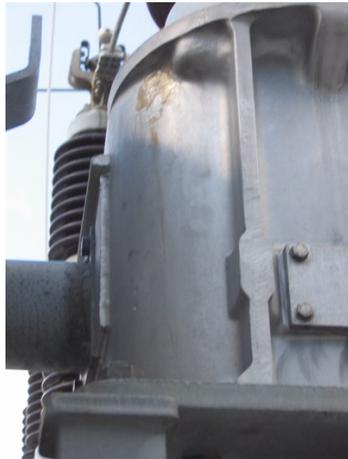
The aluminum casting on a SF6 High Voltage Breaker cracked, causing coolant to leak out and create a dangerous operating situation. Dismounting and replacing the breaker was not an option as no spare breaker was available for months.
