# BELZONA REPAIRS HIGH VOLTAGE BREAKER

ID: 5233

Industry: Power

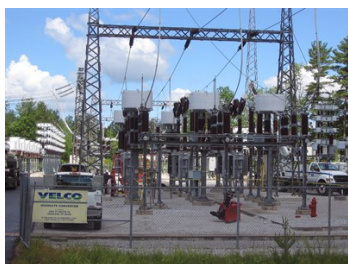
The aluminum casting on a SF6 High Voltage Breaker cracked, causing coolant to leak out and create a dangerous operating situation. Dismounting and replacing the breaker was not an option as no spare breaker was available for months.

- \* Overview of the converter station ,
- \* The leaking area ,
- \* Completed surface preparation ,
- \* Completed application ,

The surface preparation was carried out with a hand tool grinder and the application was done in accordance with Belzona Know-How System Leaflet TCC-1.

Outages are scheduled months in advance and require Grid operator approval. The station was in a scheduled outage when the leak was discovered. No replacement was immediately available so Belzona 1111 was used to get the plant back on-line on schedule, thus saving thousands of dollars.
