BELZONA PROTECTS NEW BEARING WHEEL

ID: 5235

Industry: Power
Application: FBC-Fans, Blowers and Compressors

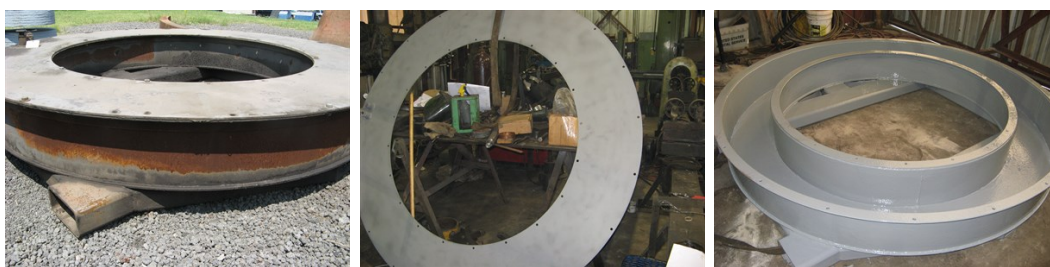
Photograph Descriptions

Problem

- * New bag house bearing wheel ,
- * Bearing wheel seat after grit blasting and degreasing ,
- * Bearing wheel seat with 2 coats of Belzona 5811 ,

The application was carried out in accordance with Belzona Know-How System Leaflet FBC-2 and the IFU for 5811. After grit blasting, cleaning and degreasing, we applied two coats of 5811 in two different colors to help detect pin holes. Material was applied with a roller and brush.
