Abrasion Control on Steel Bent Elbow Pipes with Belzona

ID: 5236

Customer Location: Mill, South Carolina
Application Date: September 2011

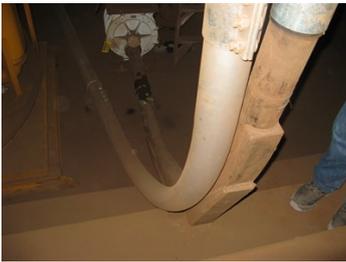
Original steel pipes are built with a 2"x4" steel base that supports the bottom of the bent steel pipe. Heavy abrasion discharge from dust and mill operation particles penetrate the cylindrical steel wall surface and erode the base requiring pipe replacement or extensive welding.

- * Steel bent discharge pipe in operation ,
- * Bent dust discharge pipe pre-drilled hole portal ,
- * Bent dust discharge pipe filled with Belzona 1391 ,
- * Bent discharge pipe plugged prior to cure of 1391 ,
