# Belzona Protects Concrete Floor from Chemical Damage

**Industry:** Chemical & Petrochemical  
**Application:** FPA-Floor Problem Areas  
**Substrate:** Concrete  
**Products:** \* Belzona 5811 (Immersion Grade) ,

**Customer Location:** South Carolina  
**Application Date:** July 2012

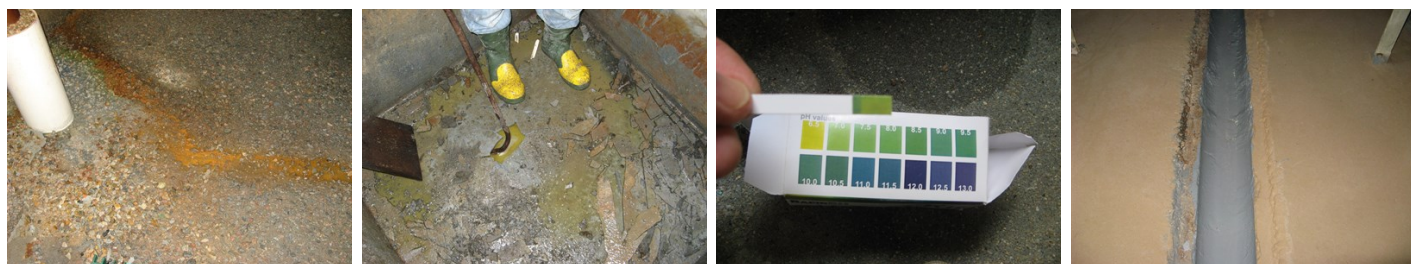
Floor, sumps and support pedestals are eroding due to sodium hypochlorate exposure to the concrete. Additionally, the sump drain has PVC which is a fire hazard and must be replaced. Chemicals will seep through the concrete into the ground if not contained.

- \* Damage to concrete floor from chemical spill ,
- \* Seepage of sodium chlorate from previous product failure where the competitive product failed on adhesion ,
- \* pH testing of concrete after power washed and prior to coating ,
- \* Two coats of Belzona 5811 to drain and floor ,

Power wash and remove any loose concrete, remove the previous epoxy from the sump containment well. Concrete was pH tested prior to application of material. Followed the IFU for Belzona 5811 as to cure and overcoat time. Belzona 5811 was applied in two coats with a roller and brush system.

Adhesion and protection from sodium hypochlorate was the principal reason Belzona 5811 was selected. The customer had a previous coating on the sump well floor and sides that delaminated and failed due to poor adhesion.
