Belzona Protects Concrete Floor from Chemical Damage

Industry: Chemical & Petrochemical
Application: FPA-Floor Problem Areas
Substrate: Concrete
Products: * Belzona 5811 (Immersion Grade) ,

Customer Location: South Carolina
Application Date: July 2012

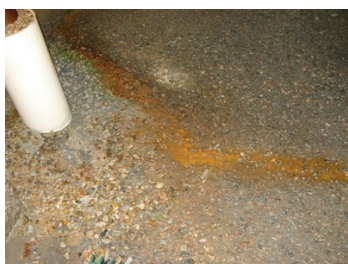
Floor, sumps and support pedestals are eroding due to sodium hypochlorate exposure to the concrete. Additionally, the sump drain has PVC which is a fire hazard and must be replaced. Chemicals will seep through the concrete into the ground if not contained.

- * Damage to concrete floor from chemical spill ,
- * Seepage of sodium chlorate from previous product failure where the competitive product failed on adhesion ,
- * pH testing of concrete after power washed and prior to coating ,
- * Two coats of Belzona 5811 to drain and floor ,

Power wash and remove any loose concrete, remove the previous epoxy from the sump containment well. Concrete was pH tested prior to application of material. Followed the IFU for Belzona 5811 as to cure and overcoat time. Belzona 5811 was applied in two coats with a roller and brush system.

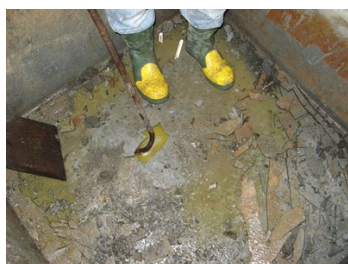
Adhesion and protection from sodium hypochlorate was the principal reason Belzona 5811 was selected. The customer had a previous coating on the sump well floor and sides that delaminated and failed due to poor adhesion.
