BELZONA REPAIRS SUMP AT A GAS STATION

ID: 5239

Industry: *General Industry*
Application: *TCC-Tanks and Chemical Containment Areas*
Substrate: *Fiberglass*
Products: ** Belzona 1291 (ES-Metal) ,
* Belzona 1161 (Super UW-Metal) ,
* Belzona 9341 (Reinforcing Tape) ,*

Customer Location: *St. Thomas, ON, Canada*
Application Date: *July 2014*

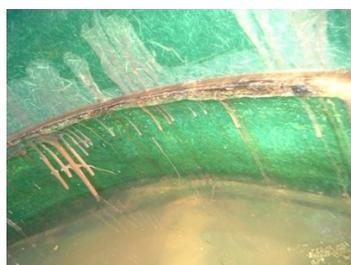
Water was flowing in through the seams inside the sump.

- * Prior to application ,
- * Application in progress ,
- * Completed application ,
- * Completed application ,

The application was carried out in accordance with Belzona Know-How System Leaflet TCC-1 for sealing cracks, porous welds, bolted and riveted joints. The area was prepared by roughing the surface. Belzona 1291 was applied by forcing the mixed material into the cracks and holes and Belzona 9341 was applied. Belzona 1161 was applied to the seam of the sump.
