# BELZONA PROTECTS POWER PLANT CONDENSERS

ID: 5241

**Customer Location:** Power Plant, Bulgaria  
**Application Date:** March-June,2014

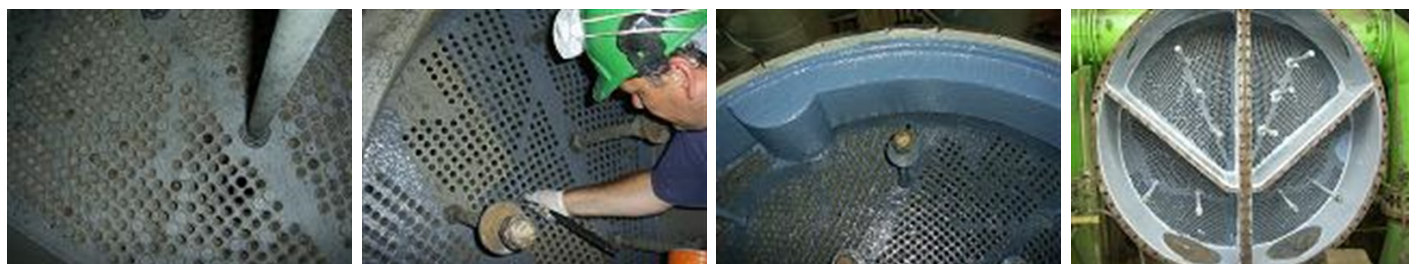
\* 1. Surface preparation of tube sheet by blast cleaning 2. Coating of tube sheet with Belzona® 1321 3. Application of first coat of Belzona® 1341 to water box 4. Completed application to tube sheet and water box ,

Application was carried out in accordance with Belzona Know-How Leaflet HEX-3. Belzona® 1321 was used to protect tube sheets from bimetallic corrosion and erosion from entrapped particles in the cooling water. Belzona® 1341 was used to protect the water boxes.

Belzona application has been done separately for each condenser thus providing uninterrupted operation of the power plant. Coating of tube sheet surface with Belzona 1321 was completed in one day. Then the water boxes and covers were coated with Belzona® 1341 over two days. Complete application done within a week thus the equipment has been put in service with minimum delay. Belzona application provides power plant with long term erosion/corrosion protection of both condensers.
