LOADING DOCK DRAIN COATED WITH BELZONA

ID: 5242

Loading dock drain.

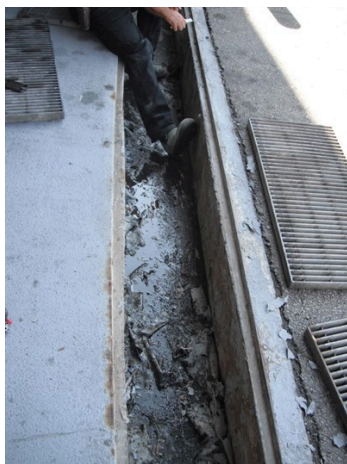
The existing coating had failed, causing blockage of the drain.

The application was carried out in accordance with Belzona Know-How System Leaflet FPA-3 for protecting floors and drains against chemical attack. The surface was prepared for application by removing the existing coating and cleaned with a high pressure washer. Belzona 5811 was applied as a two coat system with a short bristle brush.
