LOADING DOCK DRAIN COATED WITH BELZONA

ID: 5242

Industry: Buildings & Structures
Application: FPA-Floor Problem Areas
Substrate: Concrete
Products: * Belzona 5811 (Immersion Grade) ,

Customer Location: Mississauga, ON, Canada
Application Date: September 2013

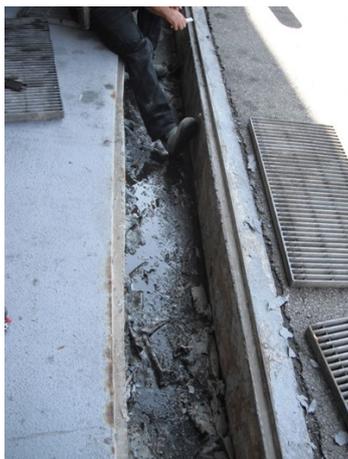
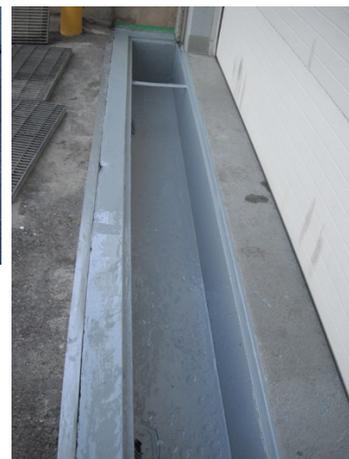
The existing coating had failed, causing blockage of the drain.

- * Prior to application ,
- * Preparation in progress ,
- * Application in progress ,
- * Completed application ,

The application was carried out in accordance with Belzona Know-How System Leaflet FPA-3 for protecting floors and drains against chemical attack. The surface was prepared for application by removing the existing coating and cleaned with a high pressure washer. Belzona 5811 was applied as a two coat system with a short bristle brush.
