BELZONA OFFERS SLIP RESISTANT COATING ON STAIRCASE

ID: 5243

Industry: Buildings & Structures
Application: FPA-Floor Problem Areas
Substrate: Concrete
Products: * Belzona 5231 (SG Laminate) ,
* Belzona 9221 (Surefoot Aggregate White) ,

Customer Location: Mississauga, ON, Canada
Application Date: August 2013

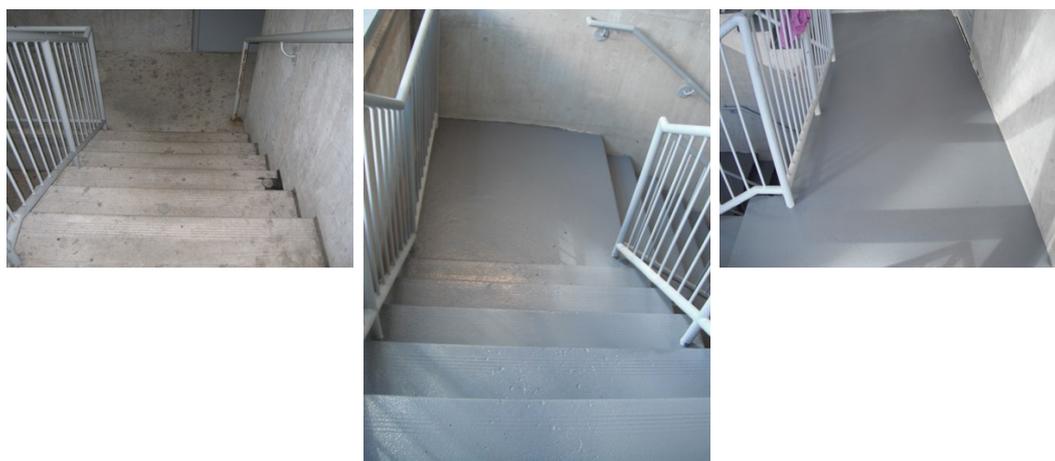
The customer wanted a coating that was slip resistant and offered protection from salt contamination.

- * Prior to application ,
- * Completed application ,
- * Completed application ,

Staircase access to car park.

The application was carried out in accordance with Belzona Know-How System Leaflet FPA-3 for protecting floors and drains against chemical attack. The surface was prepared by power washing the surface to remove dirt, debris and salt contamination. A diamond grinder was used to abrade the surface and remove small floor imperfections. Belzona 5231 was applied for the first coat and Belzona 9221 was broadcasted for increased antiskid properties. A second coat of Belzona 5231 was applied within the overcoat window in accordance with Belzona Instructions For Use.
