# BELZONA RESCUES CELL PHONE ANTENNAS

ID: 5246

Industry: General Industry  
Application: TCC-Tanks and Chemical Containment Areas  
Substrate: Steel  
Products: \* Belzona 1111 (Super Metal) ,

Customer Location: Deer Park, WA, USA  
Application Date: June 2014

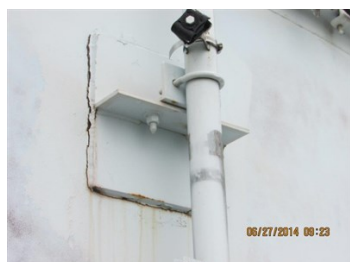
A series of steel plates with expensive cell phone antennas mounted to them on this water tower were found to be failing. The previous product had dis-bonded and they were no longer attached to the water tower.

- \* 1. Failing plate in place ,
- \* 2. Failed plate ,
- \* 3. Application complete ,
- \* 4. View from the ground ,

Previous material was removed, the surface of the plates were ground clean, and then roughened as well as the sides. The four sides of the plate were also chamfered to produce an additional mechanical bond once the Belzona 1111 had cured. The steel surface of the water tower was also ground to remove the previous material and then prepared with the MBX Bristle Blaster. Belzona 1111 was then mixed, and applied and the plate was remounted in it's original position.
