# BELZONA IS THE KEY TO A SOLID KEYWAY

ID: 5248

Industry: General Industry  
Application: MPT-Mechanical Power Transmission

Customer Location: Kettle Falls, WA, USA  
Application Date: May 2014

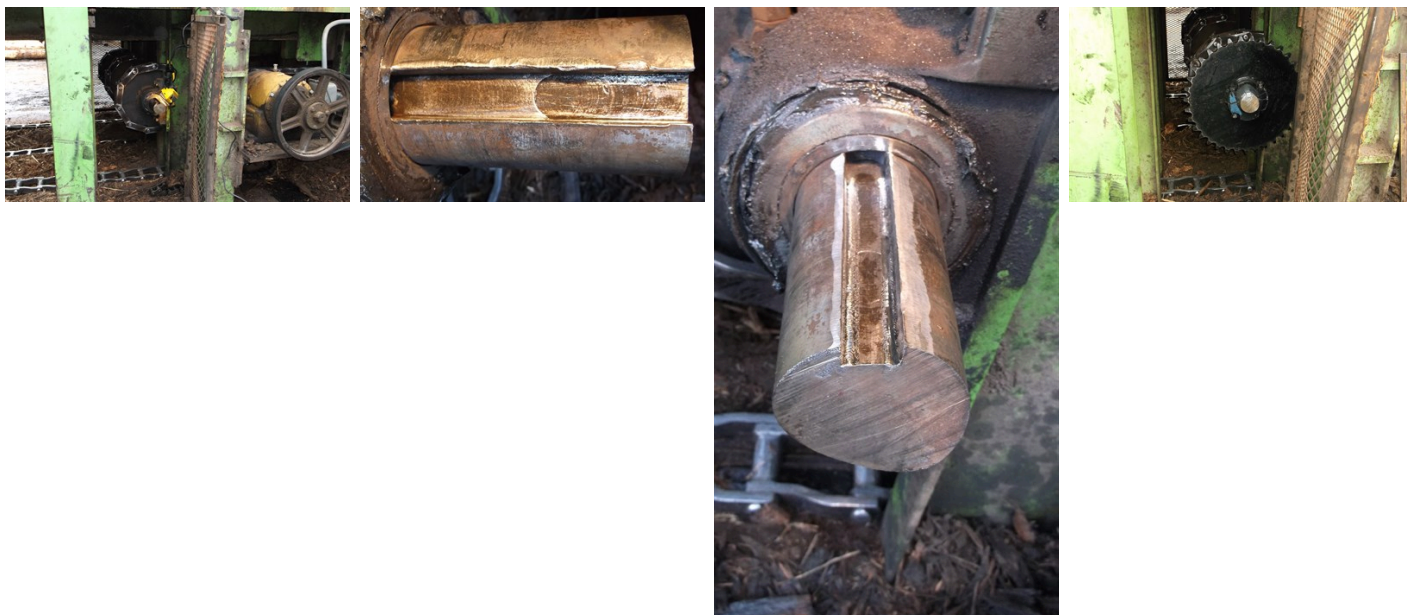
## Photograph Descriptions

This plywood mill had a problem with a damaged keyway on the shaft that runs the log entry system to the plant. They had already been forced to replace the large gear for \$3000 USD because the loose key had damaged it. The new gear was starting to show signs of damage as well. Failure of the keyway on this shaft would result in a total plant outage.

- \* Warming up the shaft ,
- \* Damaged shaft ,
- \* Ready for reassembly ,
- \* Completed application ,

Keyway was damaged and loose.

The application was carried out in accordance with a modified version of Belzona Know-How System Leaflet MPT-4. The application was completed in May so the temperatures were a little cool. The area was warmed up using a halogen lamp. A grinder was used to remove the mushroomed area on the shaft and to clean up and cut back the rest of the keyway so a solid amount of Belzona 1221 could be introduced to the damaged area. Belzona 9411 was applied in two layers to the new key and the inside and shoulders of the two-part gear. The Belzona 1221 was then mixed according to the Instructions for Use. The first layer was scrubbed in using a short bristle brush to embed material into the roughened surface. Then the remaining amount of Belzona 1221 was applied carefully to avoid any air pockets. The new key was then pressed in and the excess Belzona 1221 scraped off. The new two-part gear was then set into place and tightened down.
