BELZONA SAVES TIME AND REDUCES COSTS WITH BUSHING REPAIR

ID: 5256

Industry: *General Industry*
Application: *MPT-Mechanical Power Transmission*

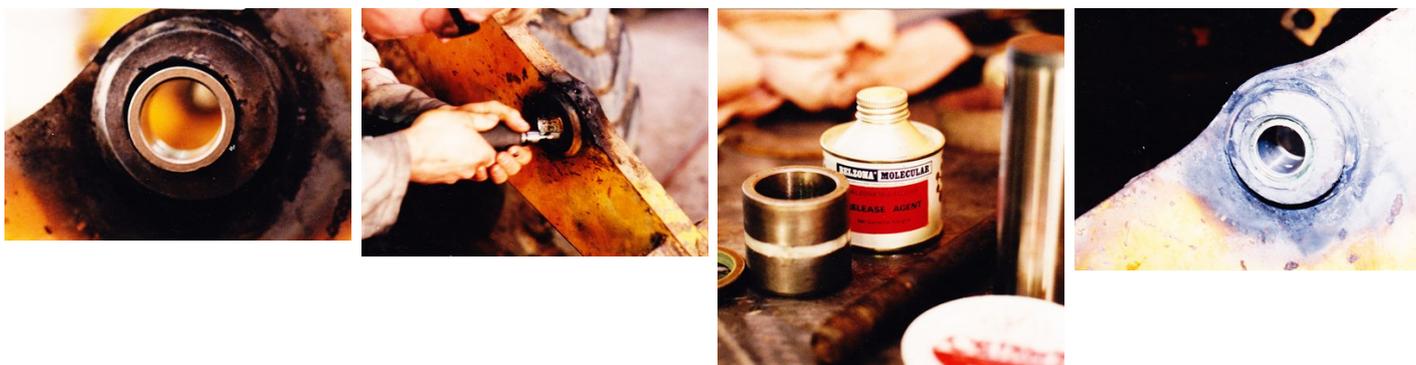
Photograph Descriptions

The loader arm bush housing was worn oversize. Welding and boring would require removing the arm.

- * Loader arms showing wear ,
- * Grinding the housing ,
- * Belzona 9411 on new bushing, grease groove full of wax ,
- * New bushing in place ,

The application was carried out in accordance with Belzona Know-How System Leaflet MPT-7. The new bushing had a grease groove around the outside. Candle wax was melted to fill the groove. After Belzona 1111 cured, a torch was used to melt the wax and a grease gun pumped in grease, pushing the melted wax out.
