# BELZONA REPAIRS RUBBER TRACK

ID: 5257

Application: SHM-Solids Handling Machinery

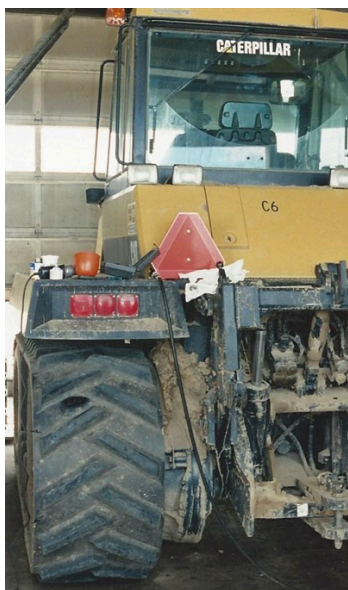
*The exposed fabric will wick in water and rot, causing the track to weaken and require replacement.*

- \* Caterpillar showing track ,
- \* Close up of the cut in the track ,
- \* Prepared and conditioned cut ,
- \* Completed application ,

The rubber track was cut open, exposing the fabric.

The cut on the track was positioned so the cut was open. The rubber was roughened and Belzona 2111 was applied in accordance with Belzona Know-How System Leaflet SHM-15.
