BELZONA REPAIRS RUBBER TRACK

ID: 5257

Industry: *General Industry*
Application: *SHM-Solids Handling Machinery*

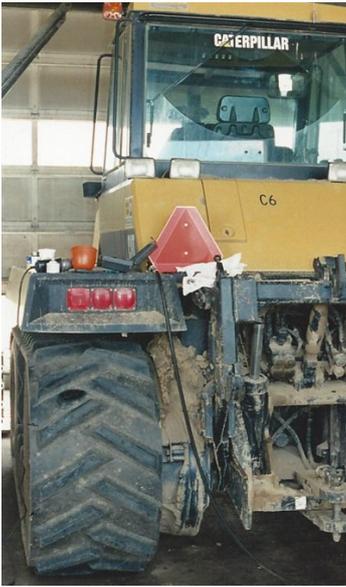
The exposed fabric will wick in water and rot, causing the track to weaken and require replacement.

- * Caterpillar showing track ,
- * Close up of the cut in the track ,
- * Prepared and conditioned cut ,
- * Completed application ,

The rubber track was cut open, exposing the fabric.

The cut on the track was positioned so the cut was open. The rubber was roughened and Belzona 2111 was applied in accordance with Belzona Know-How System Leaflet SHM-15.

Protecting the fabric has extended the life of the track, saving thousands of dollars and avoiding replacement.
