ROCK CRUSHER BEARING HOUSING REBUILT WITH BELZONA

ID: 5258

Industry: *Mining & Quarrying*
Application: *ENC-Engines and Casings*
Substrate: *Steel*
Products: ** Belzona 1111 (Super Metal) ,*

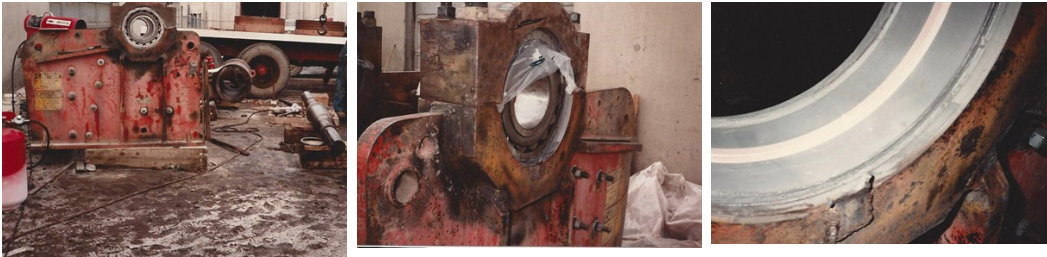
Photograph Descriptions

The bearing seized causing the housing to become oversized.

- * 1. Jaw Crusher ,
- * 2. Forming bottom half of new bearing housing. ,
- * 3. Rebuilt bearing housing showing Bondo used to maintain the bearing grease groove. ,

Bearing housing worn oversize.

Tab's were welded on to center the new bearing. 'Bondo' was used to fill the grease groove in the new bearing. The new bearing housing was formed one half at a time. Even with the Release Agent the 'Bondo' stuck to Belzona 1111. After the new housing was complete the 'Bondo' was removed with a chisel. The application was carried out in accordance with Belzona Know-How System Leaflet ENC-3b.
