# Know-How and Belzona® 4111 Make Critical Repair

ID: 526

Customer Location: Power Plant - Texas U.S.A.  
Application Date: March 2005

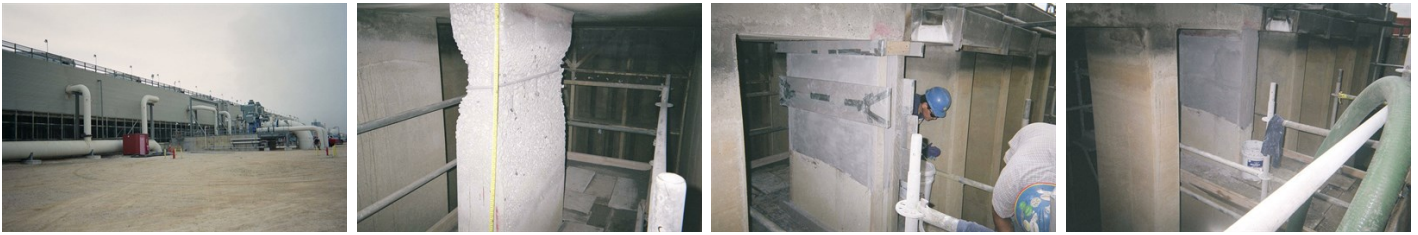
Lack of sufficient mixing of acid used for pH control in cooling tower water caused concrete deterioration on critical support members of cooling tower.

- \* Cooling tower at power plant ,
- \* Acid damaged concrete support ,
- \* Belzona® 4111 applied using formers ,
- \* Finished project ,

Application was carried out in accordance with Belzona Know-How System Leaflet HEX-6.

A short outage was planned to make other repairs in the cooling tower when damage was discovered. Client needed a quick solution. Belzona Know-How and its quick-curing Belzona® 4111 allowed this repair to be made in the short shut down period allowed. Acid feed has since been moved to prevent future damage.
