Know-How and Belzona® 4111 Make Critical Repair

ID: 526

Customer Location: Power Plant - Texas U.S.A.
Application Date: March 2005

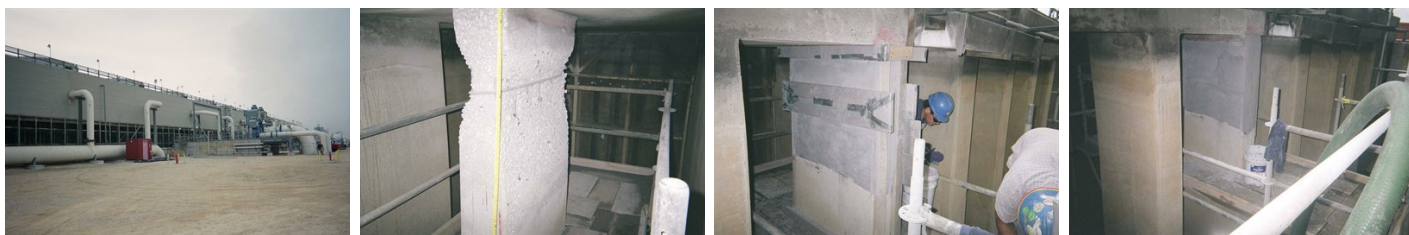
Lack of sufficient mixing of acid used for pH control in cooling tower water caused concrete deterioration on critical support members of cooling tower.

- * Cooling tower at power plant ,
- * Acid damaged concrete support ,
- * Belzona® 4111 applied using formers ,
- * Finished project ,

Application was carried out in accordance with Belzona Know-How System Leaflet HEX-6.

A short outage was planned to make other repairs in the cooling tower when damage was discovered. Client needed a quick solution. Belzona Know-How and its quick-curing Belzona® 4111 allowed this repair to be made in the short shut down period allowed. Acid feed has since been moved to prevent future damage.
