BELZONA REPAIRS ENGINE CASING

ID: 5260

Industry: *General Industry*
Application: *ENC-Engines and Casings*
Substrate: *Cast Iron*
Products: ** Belzona 1111 (Super Metal) ,*

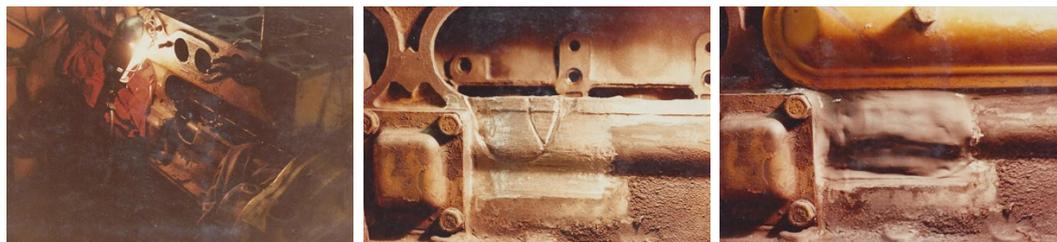
The engine block had a large piece of the casing broken off.

- * Engine block showing missing pieces ,
- * Two pieces locked in place with studs ,
- * Completed application with Belzona 1111 ,

Damaged engine casing.

The application was carried out in accordance with Belzona Know-How System Leaflet ENC-1. After the proper surface preparation, the two broken pieces were locked in place using studs and Belzona 1111 was applied.
