BELZONA SAVES DRAIN DAMAGED BY CHEMICALS

Industry: *Food & Drink*
Application: *FPA-Floor Problem Areas*
Substrate: *Concrete and Steel*
Products: ** Belzona 4111 (Magma-Quartz) ,*
** Belzona 4311 (Magma CR1) ,*
** ,*

Customer Location: *Washington, USA*
Application Date: *1993*

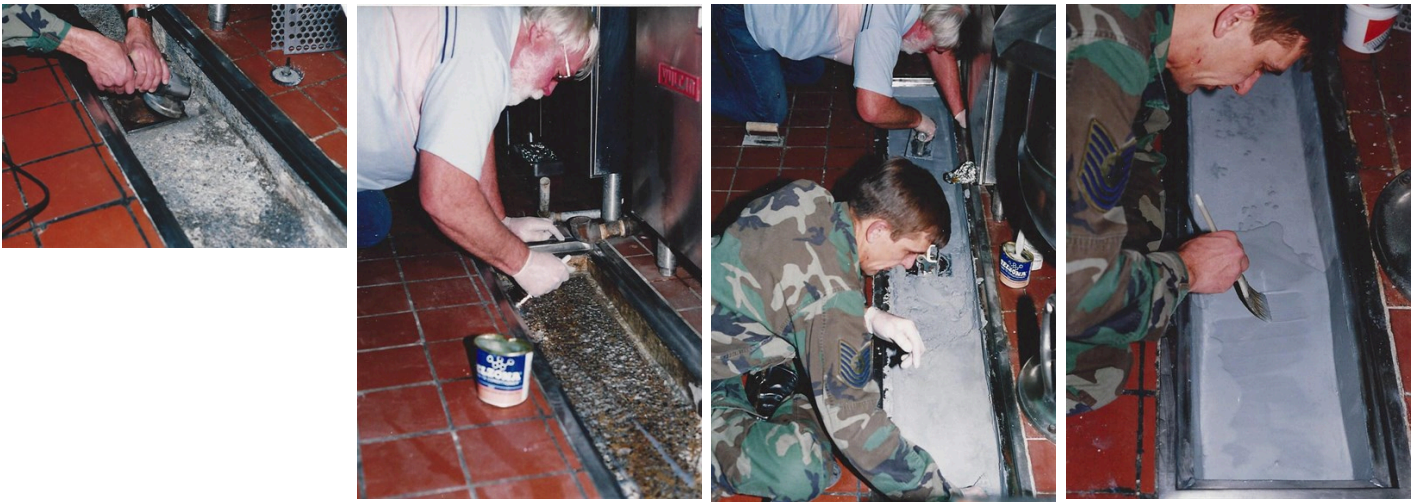
Photograph Descriptions

Chemicals used to clean equipment in the kitchen were destroying the concrete in the drain.

- * Grinding the steel drain ,
- * Conditioning the concrete ,
- * Troweling in the Belzona 4111 ,
- * A coat of Belzona 4311 brushed over the drain surface ,

Damaged concrete in kitchen drain.

The application was carried out in accordance with Belzona Know-How System Leaflet FPA-3. The concrete was cleaned and the steel was ground. Belzona 4111 was troweled over the area. A coat of Belzona 4311 was brushed over the surface, including the steel drain, to protect from chemical attack.
