BELZONA SAVES DRAIN DAMAGED BY CHEMICALS

ID: 5261

Industry: Food & Drink
Application: FPA-Floor Problem Areas
Substrate: Concrete and Steel
Products: * Belzona 4111 (Magma-Quartz) ,
* Belzona 4311 (Magma CR1) ,
* ,

Customer Location: Washington, USA
Application Date: 1993

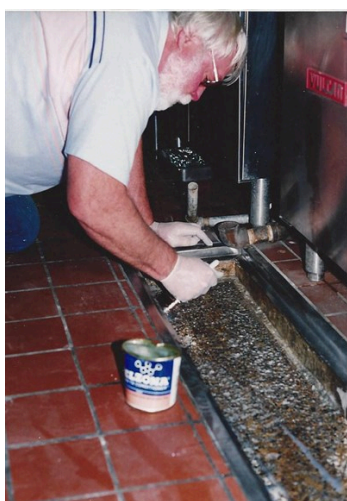
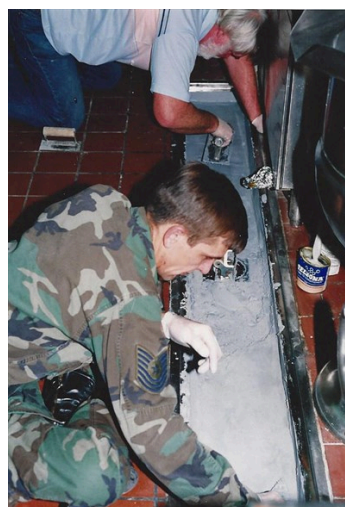
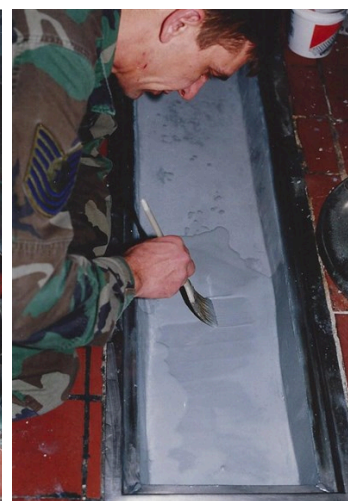
Photograph Descriptions

Chemicals used to clean equipment in the kitchen were destroying the concrete in the drain.

- * Grinding the steel drain ,
- * Conditioning the concrete ,
- * Troweling in the Belzona 4111 ,
- * A coat of Belzona 4311 brushed over the drain surface ,

Damaged concrete in kitchen drain.

The application was carried out in accordance with Belzona Know-How System Leaflet FPA-3. The concrete was cleaned and the steel was ground. Belzona 4111 was troweled over the area. A coat of Belzona 4311 was brushed over the surface, including the steel drain, to protect from chemical attack.
