BELZONA SAVES MONEY WITH RUNWAY LIGHT REPAIR

ID: 5262

Industry: *Transport*
Application: *FPA-Floor Problem Areas*
Substrate: *Concrete*
Products: ** Belzona 4111 (Magma-Quartz),*

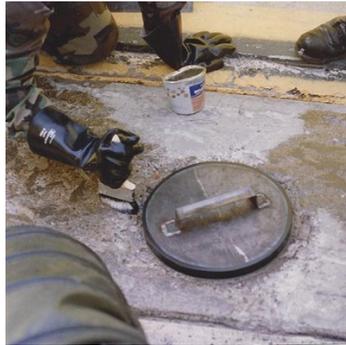
The runway lights protruded above the runway. If a snowplow hit one it would need replacement, which costs \$700 for each.

- * Runway light showing the previous ramping material removed ,
- * Conditioning the surface ,
- * Troweling down Belzona 4111 ,
- * Completing the application with Belzona 4111 after the forming lid was removed ,

A lid was made as a former so the light cover can be removed for servicing after Belzona 4111 was applied. The concrete was roughened and Belzona 4111 was troweled down to form a "ramp" around the runway light. After full cure a snowplow was used to drive over the ramp dropping the plow at 50 MPH. There was no damage to the ramp.
