BELZONA IMPROVES SAFETY WITH NONSKID SURFACE

ID: 5263

Application: FPA-Floor Problem Areas

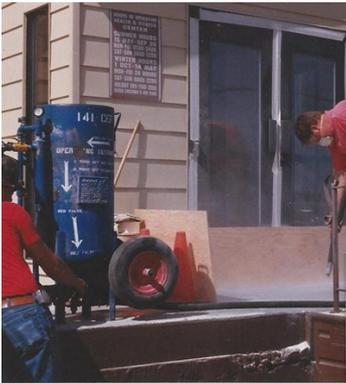
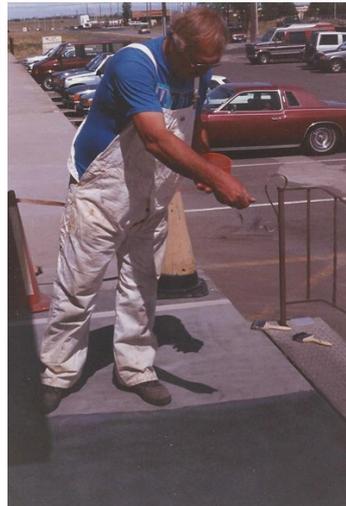
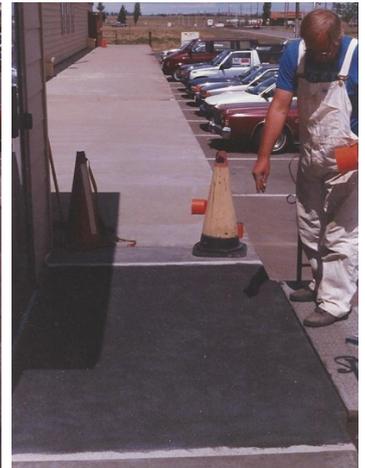
Photograph Descriptions

- * Blasting the concrete ,
- * Brushing on Belzona 4411 ,
- * Sprinkling on Belzona 9221 ,
- * Completed application ,

Application was carried out in accordance with Belzona Know-How System Leaflet FPA-8. The surface was blasted to remove all surface laitence. Belzona 4411 was brushed onto the surface and Belzona 9221 was spread on top.
