# BELZONA RESCUES A SNOW PLOW HYDRAULIC PUMP

ID: 5268

Application: ENC-Engines and Casings

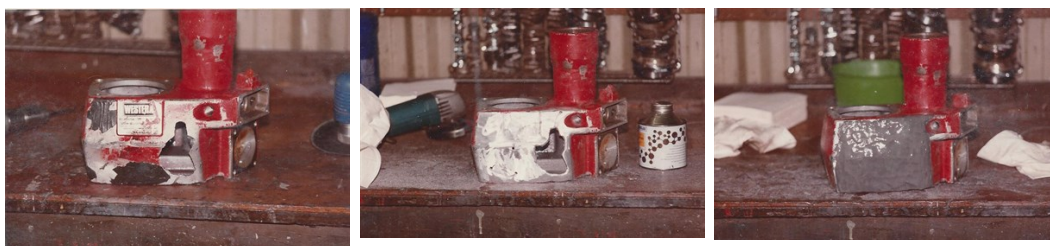
## Photograph Descriptions

The pump had been repaired with brand X, fell apart after five minutes of use.

- \* Aluminum pump casing showing the remains of Brand X failure ,
- \* Casing prepared with grinding ,
- \* Finished casing ready for service. ,

Broken pump casing

The application was carried out in accordance with Belzona System Leaflet ENC-1 using Reinforcement Sheet to bridge the hole.
