BELZONA RESCUES A SNOW PLOW HYDRAULIC PUMP

ID: 5268

Application: ENC-Engines and Casings

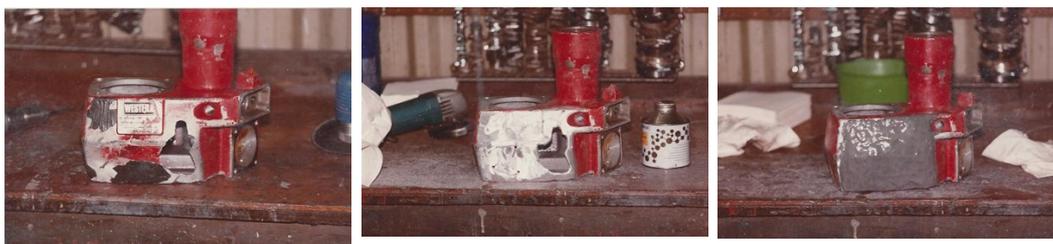
Photograph Descriptions

The pump had been repaired with brand X, fell apart after five minutes of use.

- * Aluminum pump casing showing the remains of Brand X failure ,
- * Casing prepared with grinding ,
- * Finished casing ready for service. ,

Broken pump casing

The application was carried out in accordance with Belzona System Leaflet ENC-1 using Reinforcement Sheet to bridge the hole.
