Belzona Stops Cooling Tower Leaks

Customer Location: Independent Power Plant in South Texas,
USA

Application: FPA-Floor Problem Areas

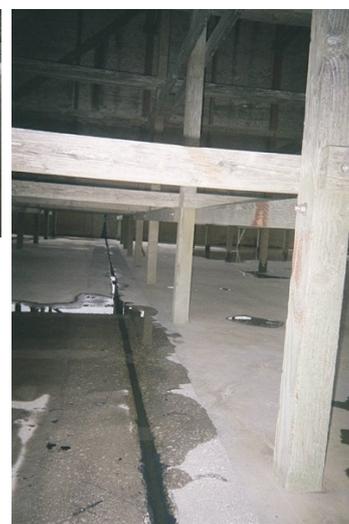
Leaks in expansion joints were causing losses of valuable cooling water. Client needed a cost effective way to stop the leaks.

- * 1. Large Cooling Tower ,
- * 2. Joint blasted and backer installed ,
- * 3. Belzona 2221 being poured into joint ,
- * 4. Next day- finished repair. Joint holds back rainwater. ,

Remove old sealants. Grit blast and and insert backer. Apply 2911 and Belzona 2211 to verticals and Belzona 2221 to horizontals.
