BELZONA OFFERS A SOLUTION TO REPAIR BUSHINGS

ID: 5271

Industry: *Pulp & Paper*
Application: *MPT-Mechanical Power Transmission*

Substrate: *Cast Steel*
Products: ** Belzona 1111 (Super Metal) ,*

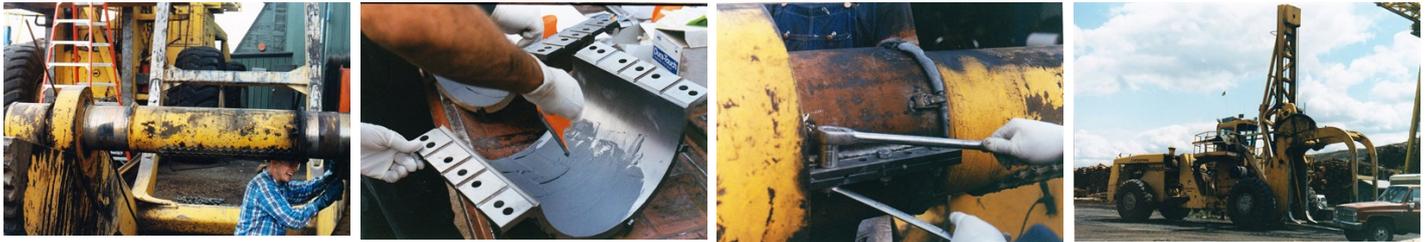
With the fork bushing worn out, the forks would bind, causing trouble unloading log trucks.

- * Worn shaft areas where bushing ride ,
- * Former built by their own machine shop ,
- * Former being bolted in place ,
- * Log loader ready to return to service ,

Worn out fork bushings.

The application was carried out in accordance with Belzona Know-How System Leaflet MPT-2. A former was built in the machine shop and tabs were welded to center it on the "shaft".
