# BELZONA REPAIRS BUSH HOUSINGS

ID: 5272

Industry: *Pulp & Paper*  
Application: *MPT-Mechanical Power Transmission*

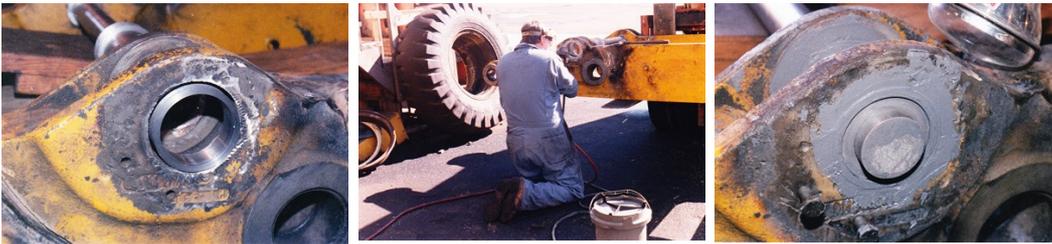
*The bush housings were worn oversize.*

- \* New bushings set in to show amount of wear ,
- \* Grit blasting the housings ,
- \* Bushings in place with shaft for alignment ,

Application was carried out in accordance with Belzona Know-How System Leaflet MPT-8. The housings were grit blasted. Belzona 9411 was brushed onto the new bushings. Belzona 1111 was applied to both surfaces and the bushings were twisted into place. A long shaft was inserted to align the four bushings.
