# BELZONA IMPROVES SAFETY WITH GRIP SYSTEM ON STEPS

ID: 5273

Industry: *Buildings & Structures*  
Application: *FPA-Floor Problem Areas*  
Substrate: *Concrete*  
Products: *\* Belzona 4411 (Granogrip) ,*  
*\* Belzona 9221 (Surefoot Aggregate White) ,*

Customer Location: *Montana, USA*  
Application Date: *1986*

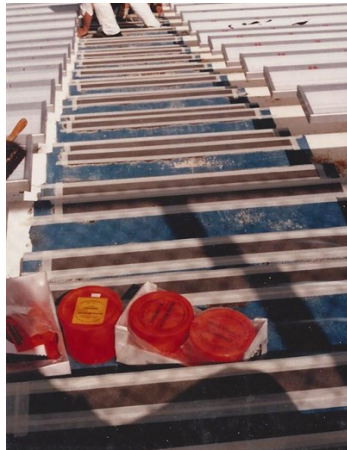
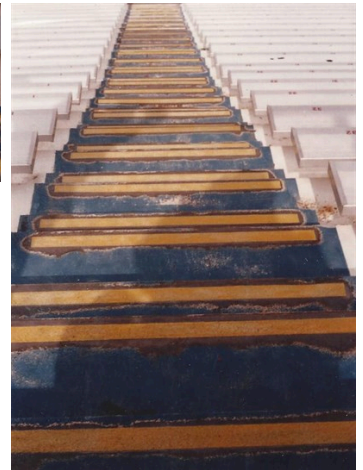
*Stick on strips had caused tripping problems.*

- \* Overview of football stadium ,
- \* Nosings blasted and masked off ,
- \* Brushing on Belzona 4411 ,
- \* Completed application, ready for repainting ,

The application was carried out in accordance with Belzona Know-How System Leaflet FPA-8. The step nosings were blasted. The nosings were masked off and Belzona 4411 was brushed on. Belzona 9221 was sprinkled on.

Stick on strips had proved to be ineffective, causing trip hazards. Belzona 4411 reduced the potential for accidents and provided an aesthetically pleasing finish.
