BELZONA IMPROVES SAFETY WITH GRIP SYSTEM ON STEPS

ID: 5273

Industry: *Buildings & Structures*
Application: *FPA-Floor Problem Areas*
Substrate: *Concrete*
Products: ** Belzona 4411 (Granogrip) ,*
** Belzona 9221 (Surefoot Aggregate White) ,*

Customer Location: *Montana, USA*
Application Date: *1986*

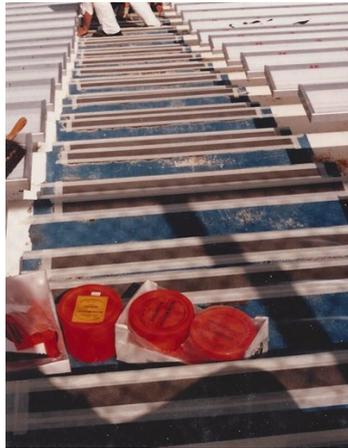
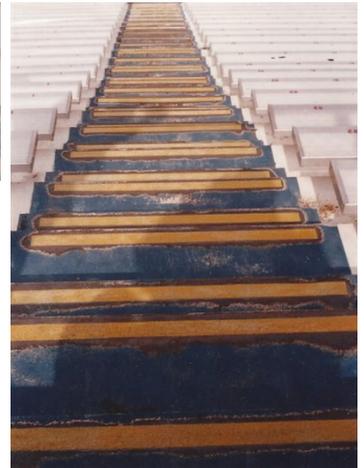
Stick on strips had caused tripping problems.

- * Overview of football stadium ,
- * Nosings blasted and masked off ,
- * Brushing on Belzona 4411 ,
- * Completed application, ready for repainting ,

The application was carried out in accordance with Belzona Know-How System Leaflet FPA-8. The step nosings were blasted. The nosings were masked off and Belzona 4411 was brushed on. Belzona 9221 was sprinkled on.

Stick on strips had proved to be ineffective, causing trip hazards. Belzona 4411 reduced the potential for accidents and provided an aesthetically pleasing finish.
