# BELZONA PROTECTS COAL DRYER FAN

ID: 5275

Industry: *Mining & Quarrying*  
 Application: *FBC-Fans, Blowers and Compressors*

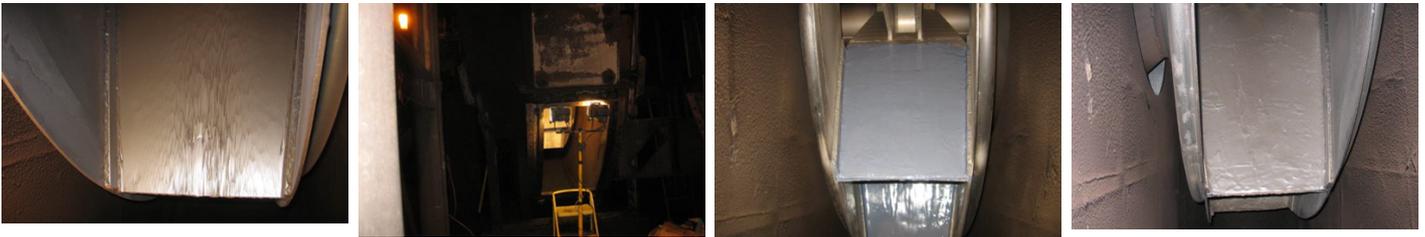
*The fan blades were being eroded by the hot coal and water mixture under operating temperatures of 110°C.*

- \* View of the wear pattern exhibited by the fan blades. ,
- \* Preparation of the metal surfaces in progress via grit blasting. ,
- \* Completed application. Eroded areas were rebuilt with Belzona 1311 and coated with Belzona 1391. ,
- \* Condition of fan blades after 12 months in service. ,

Belzona materials allowed the application to be completed with the minimum amount of downtime; only in one shift. Belzona also provided a sacrificial coating that would ensure the blades would not deteriorate to a point where total replacement became necessary. The balance of the unit was maintained by applying an equal amount of Belzona products per blade. An additional benefit from the application was that power required to run the fan was dramatically reduced (Estimated at  $\pm 15\%$ ).
