# Belzona: Stops Leaks in Cooling Towers

Industry: Power  
Application: HEX-Heat Exchangers  
Substrate: Concrete  
Products: \* Belzona® 2211 (MP Hi-Build Elastomer) ,  
\* Belzona® 2221 (MP Fluid Elastomer) ,

Customer Location: Power Plant in South Texas  
Application Date: March 2005

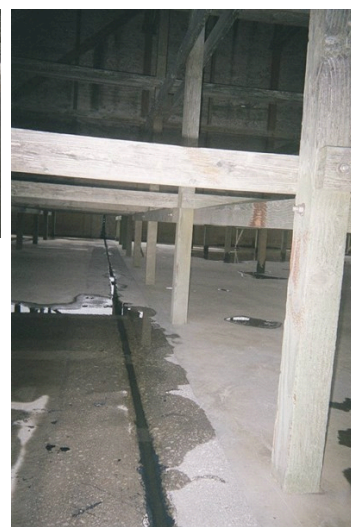
Leaking water was causing economic concerns. The old joint sealants had worn down and ground movement caused leaks in the concrete floor and walls.

- \* Cooling tower ,
- \* Expansion joints being prepared ,
- \* Belzona® 2221 being poured into backed joints ,
- \* Finished joint holds back rainwater ,

The application was carried out in accordance with Belzona Know-How System Leaflet HEX-13b.
