BELZONA REPAIRS BUTTERFLY VALVE GASKET

ID: 5280

Customer Location: MO, USA
Application Date: September 2006

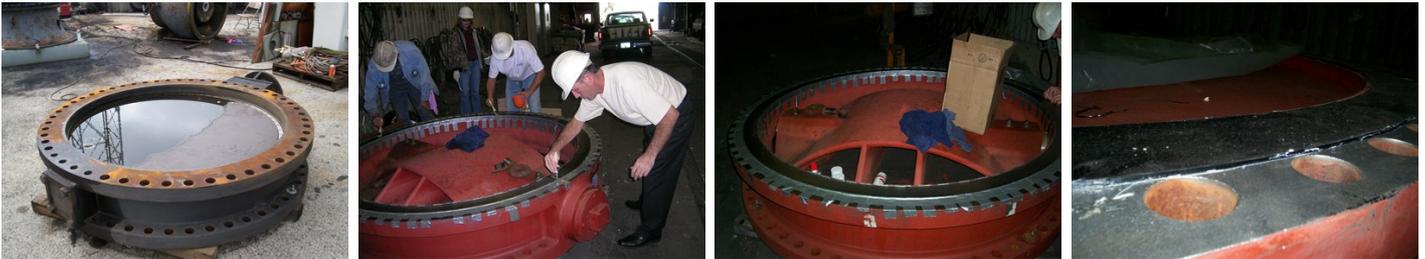
Photograph Descriptions

The butterfly valve from the main circulating water system of the power plant was removed for maintenance and required a new gasket prior to reinstallation.

- * Blasted butterfly valve gasket ,
- * Application of product ,
- * Finished repair ,
- * Close-up of gasket prior to installation ,

The application was carried out in accordance with Belzona Know-How System Leaflet GSS-1 using Belzona 2131. After grit blasting the surface, heavy gauge wire was used to form a channel to apply Belzona 2131 to the proper thickness.
