# BELZONA SEALS A CRUSHER LUBRICATION TANK

**Industry:** *Mining & Quarrying*  
**Application:** *TCC-Tanks and Chemical Containment Areas*  
**Substrate:** *Carbon steel*  
**Products:** *\* Belzona 1111 (Super Metal) ,  
\* Belzona 5811 (Immersion Grade) ,*

**Customer Location:** *Mine, Chile*  
**Application Date:** *June 2010*

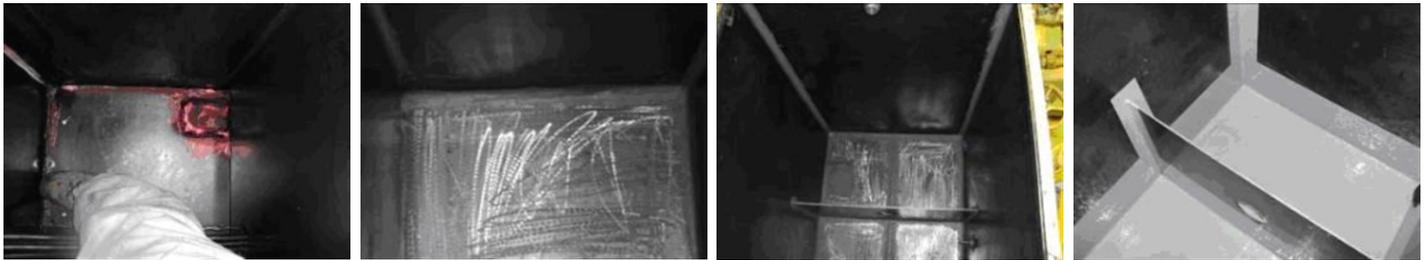
## Photograph Descriptions

*Oil filtration in the welds and joints. Leaks are detected by applying penetrating dye.*

- \* Original tank conditions where the penetration of the dye can be observed ,
- \* Prepared surface ,
- \* Another view of the prepared surface ,
- \* Completed application ,

Area of welding joints and the entire lower surface of the tank.

Mechanical cleaning with a 4½" angular grinder to create a rough surface. The application was carried out in accordance with Belzona Know-How System Leaflet TCC-1.
