BELZONA SEALS A CRUSHER LUBRICATION TANK

ID: 5294

Customer Location: Mine, Chile
Application Date: June 2010

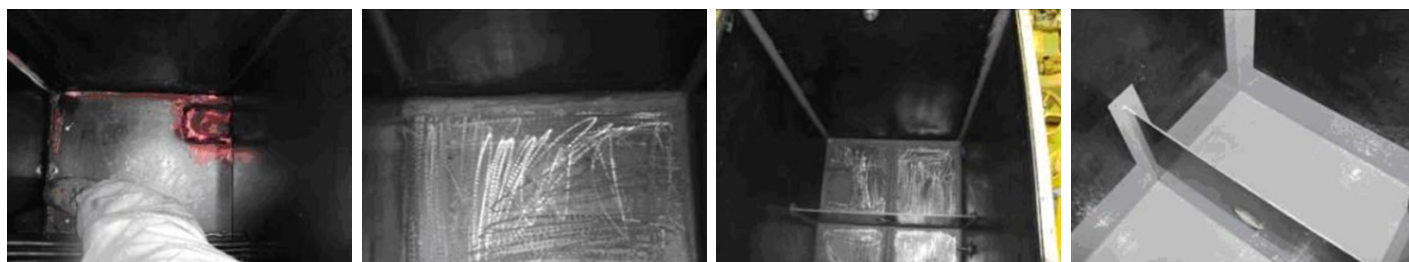
Photograph Descriptions

Oil filtration in the welds and joints. Leaks are detected by applying penetrating dye.

- * Original tank conditions where the penetration of the dye can be observed ,
- * Prepared surface ,
- * Another view of the prepared surface ,
- * Completed application ,

Area of welding joints and the entire lower surface of the tank.

Mechanical cleaning with a 4½" angular grinder to create a rough surface. The application was carried out in accordance with Belzona Know-How System Leaflet TCC-1.
