# BELZONA COATS CAPSTANS AND SAVES CUSTOMER THOUSANDS OF DOLLARS

ID: 5300

Industry: Marine  
Application: SOS-Ships and Offshore Structures

Customer Location: Marine, South Louisiana, USA  
Application Date: April 2014

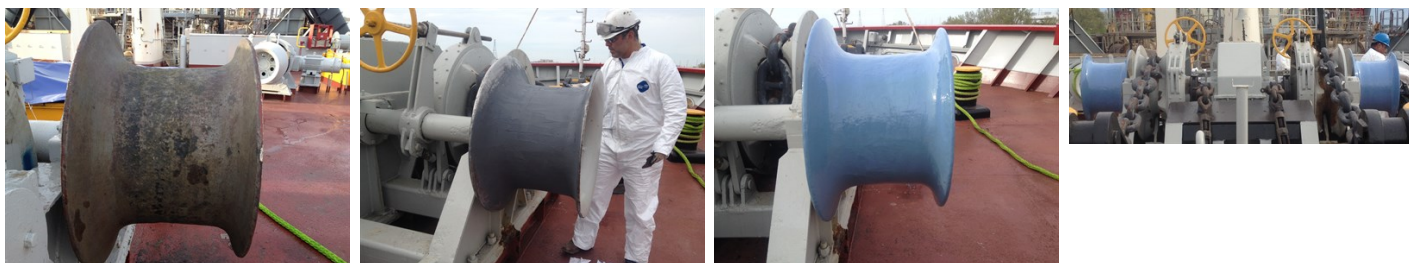
Capstans had been pitted and deformed because of chains that had been used to anchor to dock. Chains had been replaced by new technology rope which were being damaged by the uneven and rough capstan surfaces.

- \* 1. Capstan after hydro-blasting ,
- \* 2. Belzona 1311 being applied by Technician ,
- \* 3. Belzona 1341 final coating ,
- \* 4. Finished product on both capstans ,

Pitted and deformed capstans

Application was carried out in accordance with a modified version of Belzona Know-How System Leaflet SOS-2.

Belzona products were chosen as they could be applied in place, repair the metal to protect the ropes from further damage which would improve the service life of the expensive ropes as well as the metal capstans. Had the Belzona repair and coating not been used, the price to replace the ropes would have been over \$90,000. The material and labor cost was less than 10% and both
