BELZONA REBUILDS ERODED RUDDER PINTLE HOUSING

ID: 5301

Industry: *Marine*
Application: *SOS-Ships and Offshore Structures*

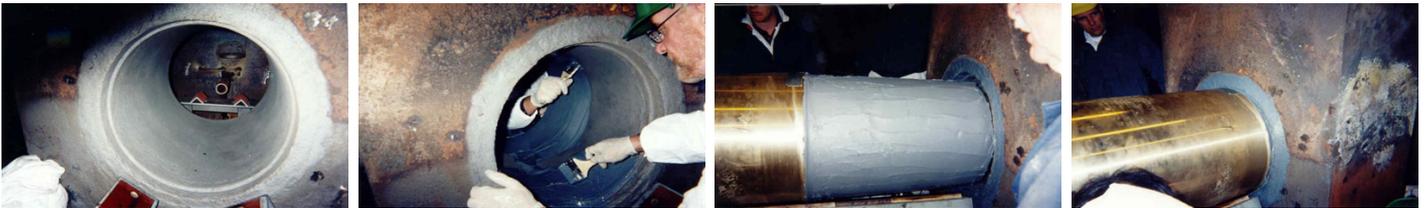
Photograph Descriptions

Bi-metallic corrosion had eroded much of the metal (about ¼ inch) from the rudder pintle housing.

- * View of blasted rudder housing. ,
- * Housing coated with Belzona 1321 to increase slip factor. ,
- * Rudder in position on horizontal slide partially inserted. ,
- * Rudder pintle inserted and allowed to set up before being removed with the aid of a 30 ton hydraulic jack. The reformed bore was inspected by the ships insurers and found to provide almost 100% contact. ,

Using Belzona eliminated the need for extensive welding and line boring. The application was completed in less than 12 hours.
