BELZONA SEALS SKYLIGHT TO PREVENT WATER PENETRATION

ID: 5302

Industry: Buildings & Structures
Application: RPA-Roof Problem Areas
Substrate: Corrugated steel
Products: * Belzona 3111 (Flexible Membrane) ,
 * Belzona 3921 (GSC Surface Conditioner) ,
 * Belzona 9311 (Reinforcing Sheet) ,

Customer Location: Cambridge, ON, Canada

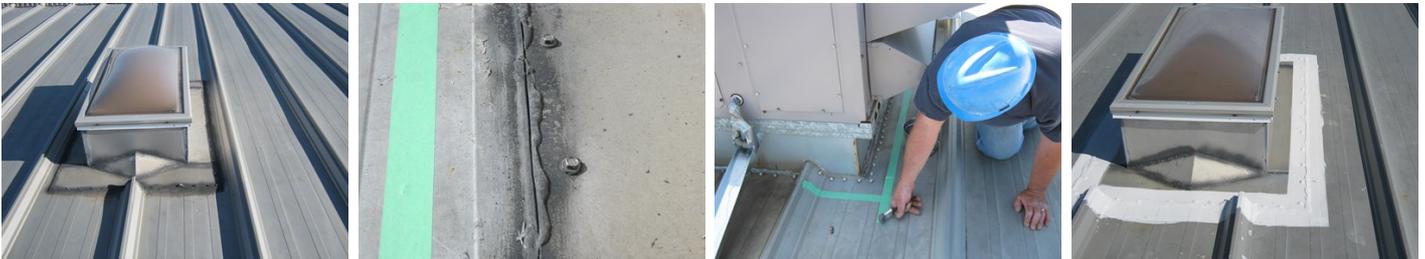
Photograph Descriptions

Water penetration between roofing sheets and around the skylight.

- * Prior to application ,
- * Preparation in progress ,
- * Application in progress ,
- * Completed application ,

The application was carried out in accordance with Belzona Know-How System Leaflet RPA-01 for repairing and sealing joints and seams. A wire brush was used to remove any loose adherent and flaking rust and Belzona 3921 was applied to the prepared surface. Belzona 9311 was laid over the conditioned area and Belzona 3111 was applied with a soft bristle brush as a two coat system in accordance with Belzona Instructions For Use.

Revisited in June 2014 with no leaks to date. Belzona 3111 is a single component, solvent free, microporous coating for the
