# BELZONA REPAIRS AND RESURFACES FLOOR

ID: 5303

Application: FPA-Floor Problem Areas

Floor area at a food production facility.

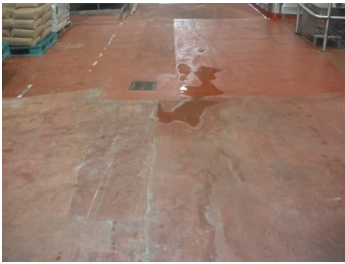
Over time, the floor had settled, resulting in standing water not flowing into the drain. This created an environmental hazard.

- \* Prior to application ,
- \* Preparation in progress ,
- \* Completed preparation ,
- \* Completed application ,

The application was carried out in accordance with Belzona Know-How System Leaflet FPA-1 for rebuilding worn and damaged floor surfaces. The surface was prepared by using a pneumatic hammer and ground to remove the existing concrete. Belzona 4911 was applied using a brush and Belzona 4131 was applied directly onto the conditioned surface, initially spreading to a general level using normal screeding techniques and then using a metal straight edge to achieve a uniform thickness.
