# BELZONA PROTECTS ACID VESSEL FROM CHEMICAL ATTACK

ID: 5306

Acid production vessel.

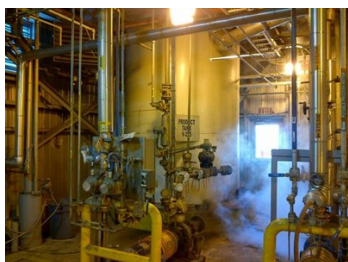
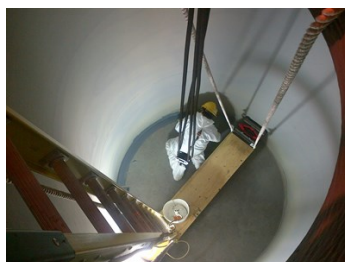
*The acid had damaged the teflon coating.*

- \* Acid vessel ,
- \* Prior to application ,
- \* Application in progress ,
- \* Completed application ,

The application was carried out in accordance with Belzona Know-How System Leaflet TCC-3 for repairing/renewing damaged linings. Abrasive blasting was done to prepare the surface and Belzona 4311 was spray applied as a two coat system in accordance with Belzona Instructions For Use.
