BELZONA PROTECTS ACID VESSEL FROM CHEMICAL ATTACK

Industry: *General Industry*
Application: *TCC-Tanks and Chemical Containment Areas*
Substrate: *Steel*
Products: ** Belzona 4311 (Magma CR1),*

Customer Location: *Niagara Falls, ON, Canada*
Application Date: *June 2013*

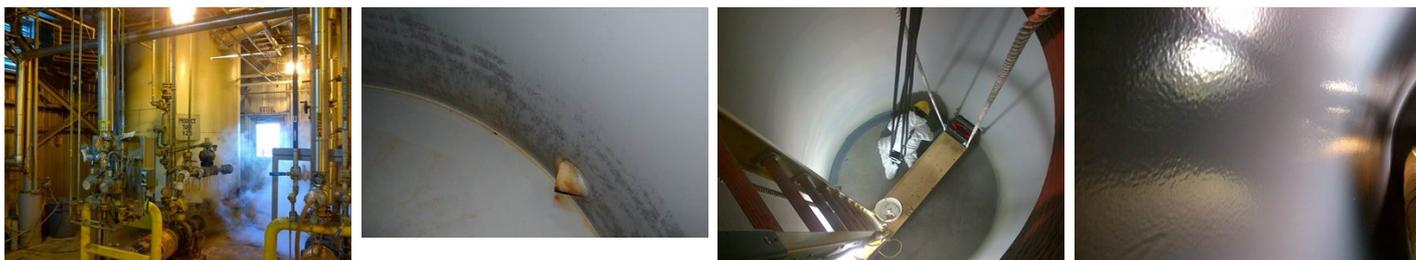
Photograph Descriptions

The acid had damaged the teflon coating.

- * Acid vessel ,
- * Prior to application ,
- * Application in progress ,
- * Completed application ,

The application was carried out in accordance with Belzona Know-How System Leaflet TCC-3 for repairing/renewing damaged linings. Abrasive blasting was done to prepare the surface and Belzona 4311 was spray applied as a two coat system in accordance with Belzona Instructions For Use.
