# Belzona Rebuilds & Protects Pump Impeller

ID: 531

Industry: Water / Wastewater

Application: CEP-Centrifugal Pumps

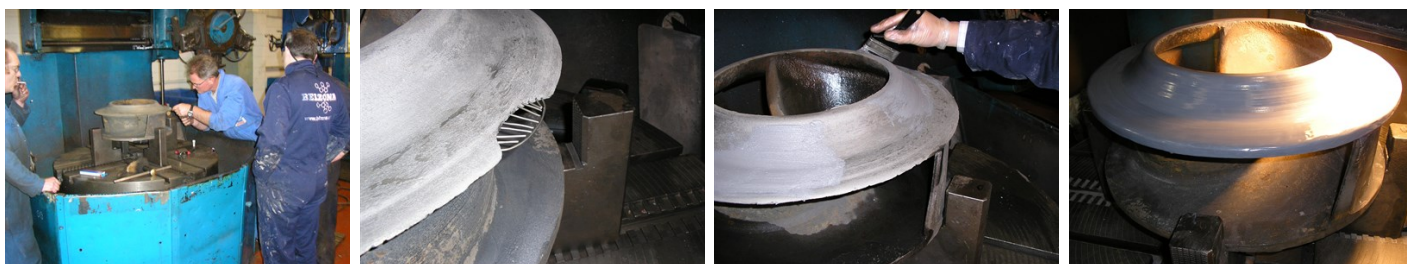
*Impeller had moved on its shaft causing it to run against the casing. This resulted in severe abrasive wear and mechanical damage.*

- \* Impeller on vertical borer prior to cleaning and refurbishment ,
- \* View of wear and mechanical damage. Wire framework was used to reinforce repair ,
- \* Application of Belzona® 1111 underway ,
- \* Completed impeller after application of final coats of Belzona® 1321 ,

Application was carried out in accordance with Belzona Know-How System Leaflets CEP-1 and CEP-3.

Previously, impellers in this condition were not considered repairable resulting in delivery lead times to source a new part as well as the associated replacement costs. The repair using Belzona meant the part could be returned to service within 48 hours.
