BELZONA PROTECTS NEUTRALIZATION PIT

ID: 5312

Problem

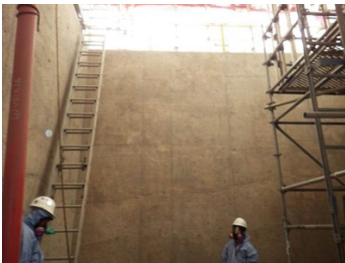
Existing rubber liner had torn, allowing the water, caustic and acid to attack the concrete substrate.

- * Prior to application ,
- * Rebuilt substrate ,
- * Application in progress ,
- * Completed application ,

The application was carried out in accordance with Belzona Know-How System Leaflet WPA-4 for rebuilding vertical and overhead masonry substrates, FPA-1 for rebuilding worn and damaged floor surfaces and TCC-15 for sealing and protecting containment areas. The walls were rebuilt with Belzona 4911 and Belzona 4141. The floor was rebuilt with Belzona 4911 and Belzona 4131. Protection was completed by spraying one coat of Belzona 5811 and two coats of Belzona 4311 by plural sprayer.
