BELZONA PROTECTS NEUTRALIZATION PIT

ID: 5312

Industry: *General Industry*
Application: *TCC-Tanks and Chemical Containment Areas*

Customer Location: *Corunna, ON, Canada*
Application Date: *August 2014*

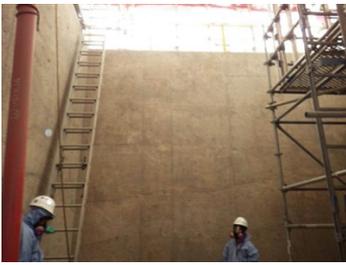
Existing rubber liner had torn, allowing the water, caustic and acid to attack the concrete substrate.

- * Prior to application ,
- * Rebuilt substrate ,
- * Application in progress ,
- * Completed application ,
