BELZONA REPAIRS LEAKS IN WATER FEATURE

ID: 5315

Application: *RPA-Roof Problem Areas*

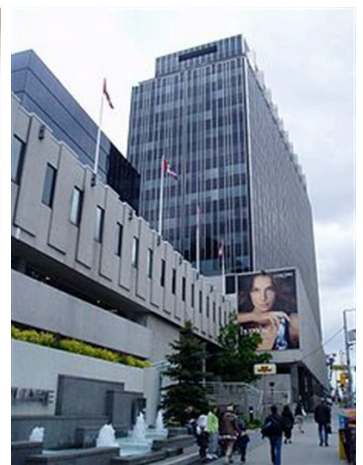
Leaks in the water feature.

- * Water feature ,
- * Prior to application ,
- * Completed application ,
- * Water feature back online ,

The application was carried out in accordance with Belzona Know-How System Leaflet RPA-6 for waterproofing gutters and standing water areas. The area was cleaned of any debris and blasted to prepare the surface. Belzona 3911 was applied to the concrete and Belzona 3921 was applied to the steel using a brush. Belzona 3111 was applied to the surface using a brush as a two coat system.
