BELZONA PREVENTS EROSION-CORROSION ON PUMP

ID: 5318

Industry: *Fluid Flow*
Application: *CEP-Centrifugal Pumps*
Substrate: *Steel*
Products: ** Belzona 1341 (Supermetalgilde) ,*

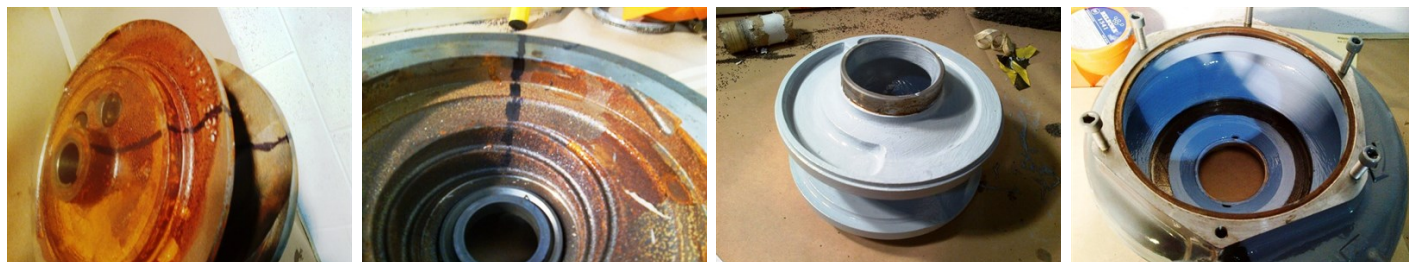
Photograph Descriptions

Erosion/Corrosion of the pump volute and impeller.

- * Prior to application ,
- * Prior to application ,
- * Completed application ,
- * Completed application ,

The application was carried out in accordance with Belzona Know-How System Leaflet CEP-3 for applying internal coatings. The pump was $\text{\textcircled{B}}$ blasted to prepare the surface for application. Belzona 1341 was applied using a brush as a two coat system in accordance with Belzona Instructions For Use.
