BELZONA STEPS UP TO THE CHALLENGE

Application: FPA-Floor Problem Areas

Spalled concrete around hand rail post.

Stairs to a municipal recreational centre.

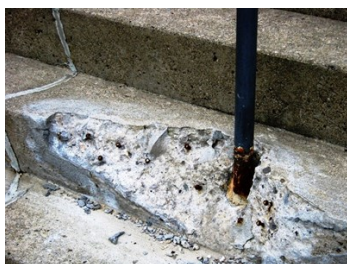
- * Prior to application ,
- * Preparation in process ,
- * Application in process ,
- * Completed application ,
