# Belzona Rebuilds Shaft on Blanching Machine

ID: 532

Industry: General Industry  
Application: MPT-Mechanical Power Transmission

Customer Location: Frozen Food Manufacturer UK  
Application Date: February 2005

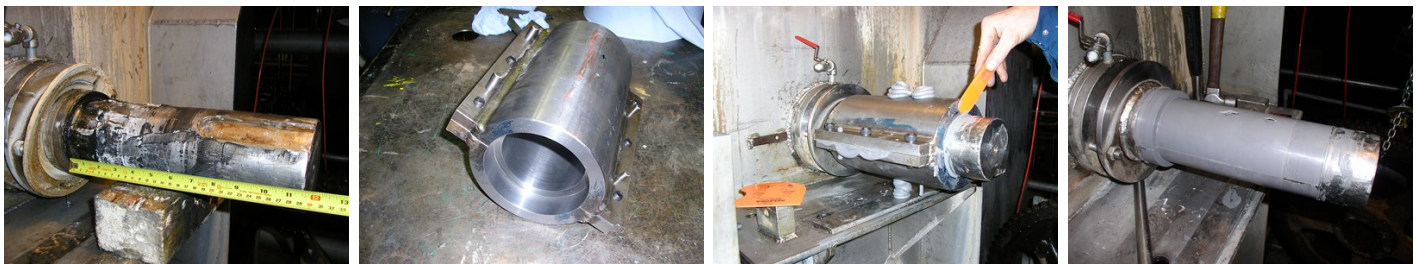
## Photograph Descriptions

Shaft was worn in the bearing area. This increased pressure on the bearings resulting in a very short service life.

- \* View of worn bearing seat area on shaft. ,
- \* View of former. A stepped former was required to allow it to clamp and locate onto undamaged areas of the shaft. ,
- \* Former after clamping in position. ,
- \* Completed shaft rebuild using Belzona® 1111. Note the step has been rebuilt as well. ,

Previously this shaft had been welded up in position and the bearing seat area rough ground back to size. The shaft cannot be taken out without major strip down so an in-situ repair has to be done. The Belzona forming technique produced the precise required diameter.
