BELZONA REPAIRS AIR HANDLING EQUIPMENT

ID: 5322

Industry: Heating, Ventilation & Air Conditioning
Application: MPT-Mechanical Power Transmission

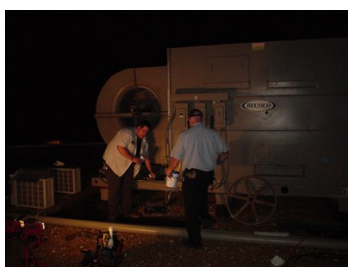
One of the bearings on this office building's air handler system failed and severely gouged into the fan's shaft. The cooling system was nearly crippled with a triple digit, Midwest July heat.

- * Air handler fan threw a bearing in the early a.m.; building without conditioned air for over 12 hours. ,
- * Customer secured the shaft for early a.m. repair. ,
- * Belzona repair completed before 6:00 a.m. ,
- * Completed application of shaft and ready to return to service that morning. ,

The shaft was supported and the pillow block was removed, exposing the damaged area. A suitable former was treated with Belzona 9411 and the bearing surface was roughened and degreased. Belzona 1111 was mixed and applied, then the form was clamped in place. After a short cure, a new bearing was installed and the air handler was placed back on-line. The application was carried out in accordance with Belzona Know-How System Leaflet MPT-2.
